PALS Cultural Landscape Study: Cedar Hill Cemetery, Suitland, Maryland

Course #: HISP-GAPALS-F2020-2

The University of Maryland – College Park

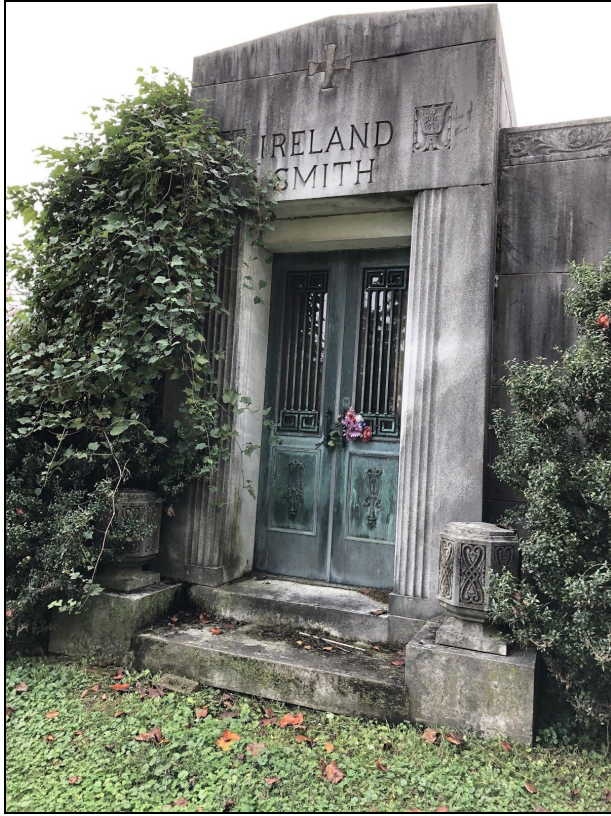
Photo 4: Family mausoleum, Sections 2 and 4, Cedar Hill Cemetery
Photo Source: Photograph taken by PALS Research Team

Sections 2 and 4 have some of the oldest graves in the cemetery, dating back to the late 1800s. Although most of the headstones are in good condition, some are leaning, and one has been toppled over. Generally, the grave markers are arranged in rows, although the orientation of these rows varies throughout the section.

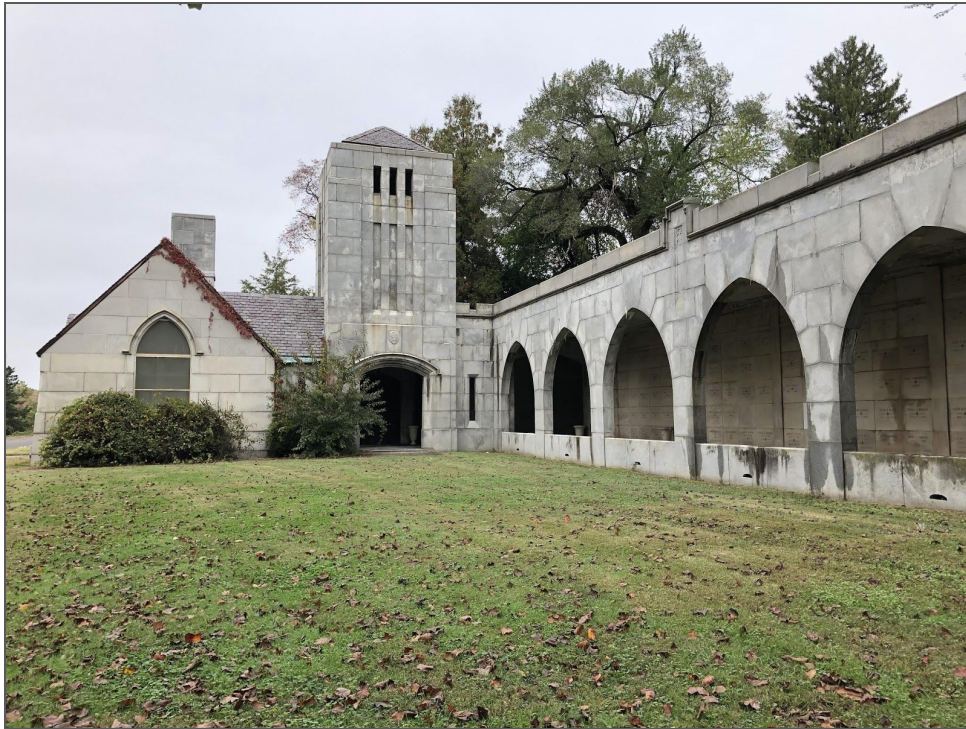
Abandoned Chapel and Mausoleum

Photo 8: Abandoned chapel and mausoleum, Cedar Hill Cemetery
Photo Source: Photograph taken by PALS Research Team

In the center of Cedar Hill Cemetery lies a small chapel and mausoleum, which appears to be in extremely poor condition. The building has an L-shaped footprint and is characterized by large, uniform stone block façades, thin, everted joints, and pointed arches over window and door openings. Several of the windows and main openings have drip-mold crown elaborations. The building's west side faces a cemetery road and is fronted by several decorative cannons pointing west. Overgrown vegetation in front of the cannons blocks the view of the cemetery and also covers a stone stairway leading to the front of the chapel. Based on the stairs and direction of the cannons, it is evident that the vegetation has become overgrown and may not have been in existence when the chapel was built. The building's east side is partially set into a steep hill, allowing pedestrians to walk directly onto the roof in the rear of the building.

A one-story chapel, measuring roughly fifty feet long, is at the north end of the building. The chapel has a moderately pitched, side-gabled slate roof and paneled metal entrance doors set within a small, slightly projecting center gable. The entrance doors are flanked by tall stone urns. Chapel windows appear to be extremely rusted. The roof is visibly failing in the rear, where it is slate toward the ridge, and a mix of metal and shingles toward the eaves. There is also vegetation growing on the chapel roof. An attached stone tower on the north side of the chapel, shows evidence of displacement and spalling. A large, square tower, attached to the chapel's east side, appears to function as a mausoleum.

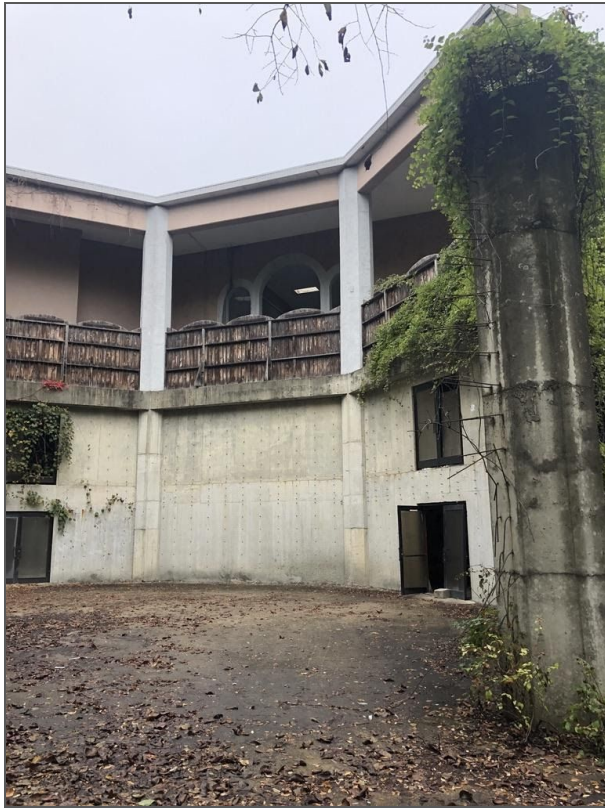
Ukrainian Mausoleum

Photo 9: Ukrainian Mausoleum, Cedar Hill Cemetery
Photo Source: Photograph taken by PALS Research Team

A partially completed mausoleum, originally intended to serve as a burial place for the D.C. Metropolitan region's Ukrainian population, sits near Pennsylvania Avenue on the northwest corner of Cedar Hill's property boundary. The building, constructed in the late 1980s, was never completed. Although it was originally intended to have multiple wing extensions, only one wing was built. The completed wing is on the northern end of the building, facing Pennsylvania Avenue. On the building's south side, hidden from view, are the foundations for the other wings. These foundations are overgrown with vegetation.

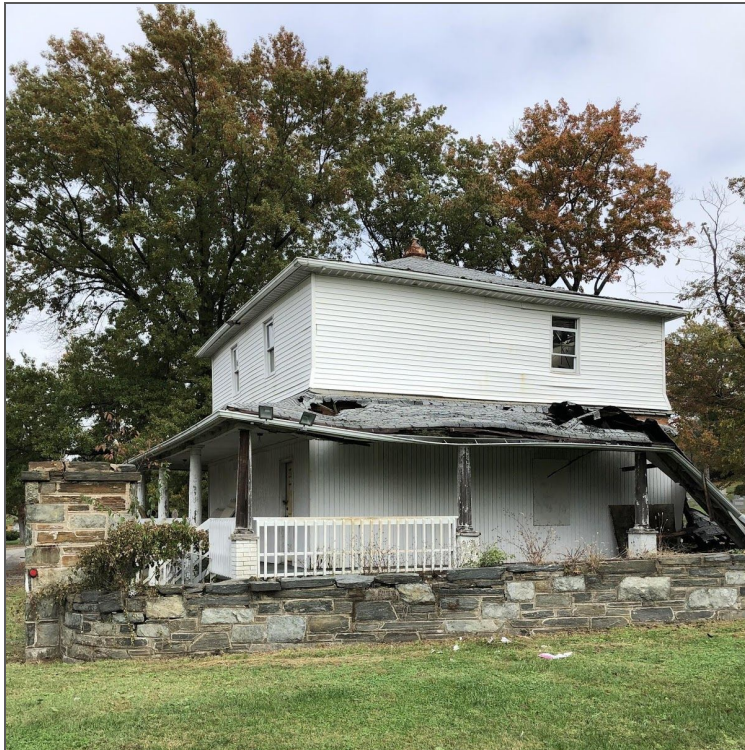
Sales House

Photo 10: Sales house, Cedar Hill Cemetery
Photo Source: Photograph taken by PALS Research Team

A two-story frame house, in a state of advanced disrepair, is located on the west side of Cedar Hill. The house sits directly behind a side entrance to the cemetery from Suitland Road. The side entrance, which appears to no longer be in use, looks markedly like the main entrance, with similar stone pillars. The simple house has white painted wood siding and a one-story wrap-around porch. The house has a hipped shingle roof and one-over-one sash, wood frame windows. The shingled roof of the porch is extremely damaged and appears to have failed entirely on the south corner of the house.

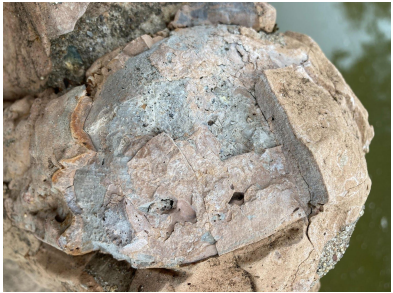
Issue	Description	Image
Spalling	Surface-level pieces of concrete break off or deteriorate. Spalling can be caused by oxide jacking, moisture infiltration, freeze-thaw cycles, salts, etc.

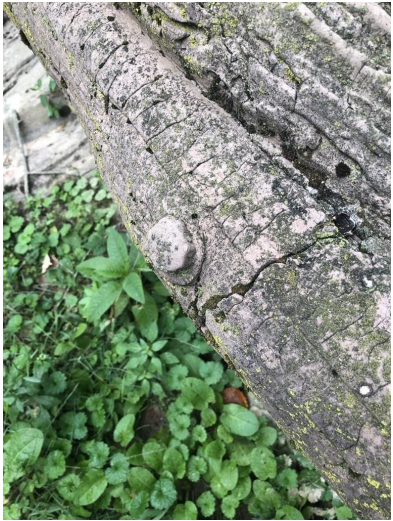
Cracking	Complete or incomplete separation of concrete in two or more parts due to fracturing or breaking. Cracking can be caused by freeze-thaw cycles, oxide jacking, moisture infiltration, settlement, drying shrinkage, chemical reaction, corrosion, weathering, poor construction practices, externally applied overloads, etc.

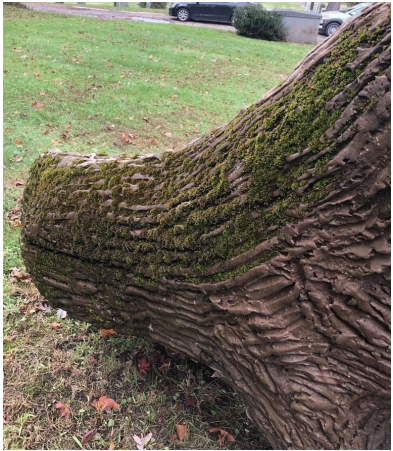
Biological Growth	The growth of vegetation on a surface. Biological growth on concrete can be caused by a reduction in surface alkalinity over time due to exposure to carbon and rainfall, thereby creating a more suitable environment. As the biological growths become larger, the roots can grow into cracks and increase stresses that lead to larger cracks and spalling.

For the issues that plague each sculpture, notably biological growth, several rounds of water washing may be the best first option, followed by water washing with non-ionic detergents. While an acid-based cleaning solution is recommended for concrete since concrete is not an acid-sensitive masonry, the outer layer of the sculptures is primarily cement and may react differently to acidic cleaners. In addition, it's not clear whether an acidic cleaner will affect the pigmentation of the outer layer. In regard to the graffiti painted inside the hollow tree sculpture, it is often best removed using a poultice. A poultice is composed of a clay powder or absorbent material combined with a liquid to form a paste that is applied to the stained or painted area. As with all cleaning methods, it is best to conduct limited tests prior to using a certain treatment on the entire sculpture.⁶⁴

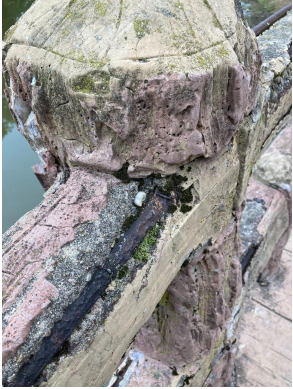
Exposed Rebar	Structural elements of concrete structures that are exposed to the elements when concrete breaks away. Rebar can be exposed due to concrete spalling, which is caused by the corrosion of the rebar due to a gradual reduction in the alkalinity of concrete and the steel's exposure to moisture and oxygen.

Another cause of deterioration and subsequent exposure of the structural rebar can be caused by “oxide jacking.” As the concrete’s high alkalinity, which prevents or minimizes corrosion, lessens over time, the reinforcing steel rods in concrete can begin to corrode. As the byproducts of corrosion expand (the volume of the rods can increase up to six times more than their original size), high stresses are created on the adjacent concrete, which eventually cracks and becomes displaced or spalls.⁶³

If the severe spalling is being caused by oxide jacking, impressed current cathodic protection (ICCP) could help prevent further deterioration. In the ICCP process a small electrical current is sent through the concrete to the steel reinforcement to stop the corrosion of the steel. Installing ICCP can help control corrosion for many years. However, this method may be visually obtrusive, depending on the instruments used.⁶⁵

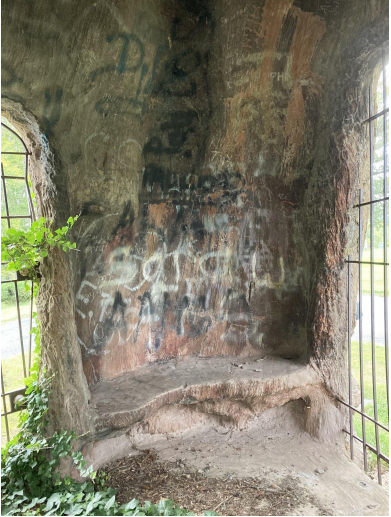
Graffiti	Writing or drawings sprayed or scribbled illicitly on walls or other surfaces in public places.

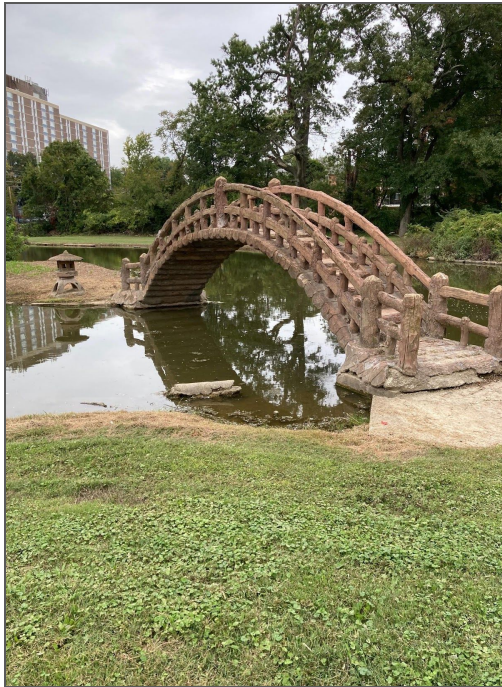
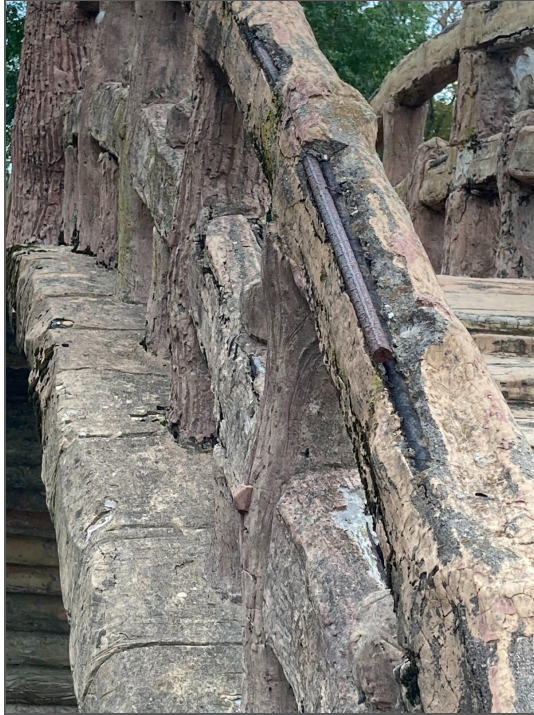
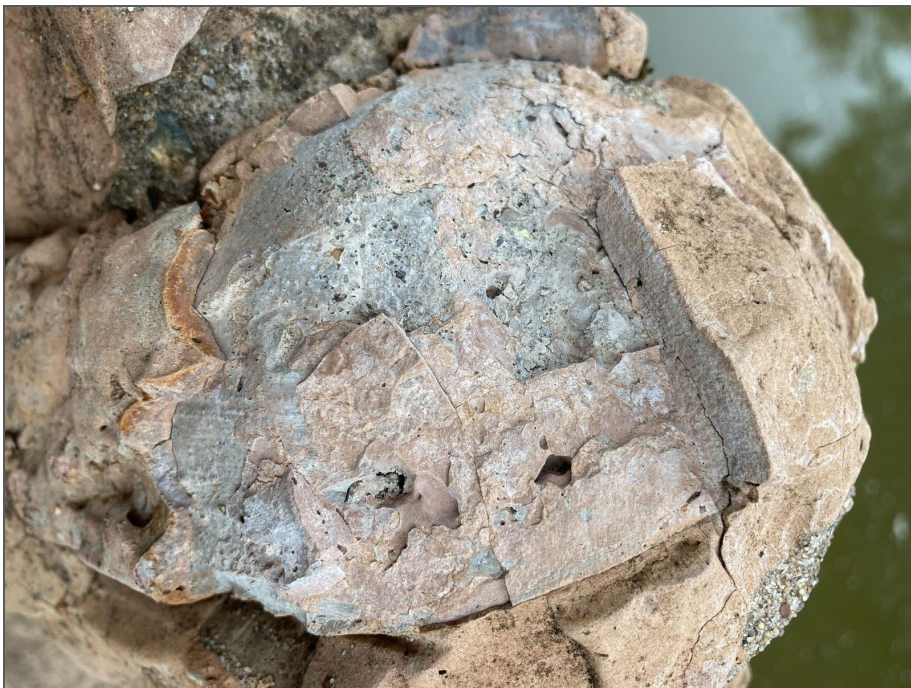
Condition: The bridge is in fair condition and displays some evidence of deterioration. There is biological growth on some sections, indicating moisture infiltration. The concrete has cracked and spalled in some areas, exposing the rebar and metal lath underneath.

Photo 12: Bridge of Life, Cedar Hill Cemetery

Photo 13: Exposed rebar and metal lath on the Bridge of Life, Cedar Hill Cemetery
Photo Source: Photograph taken by PALS Research Team

Photo 14: Spalled or debonded broken outer concrete layer revealing the base concrete layer
Photo Source: Photograph taken by PALS Research Team

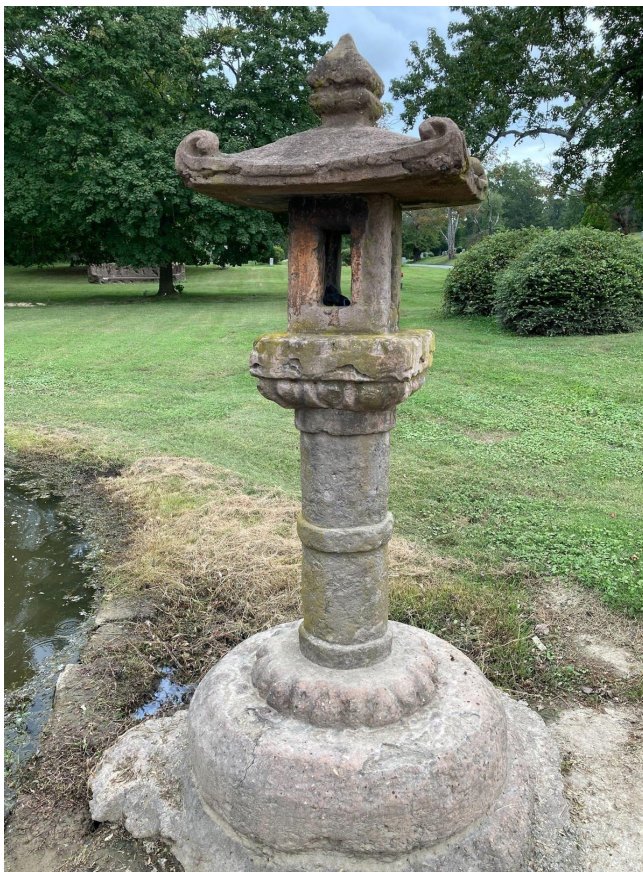
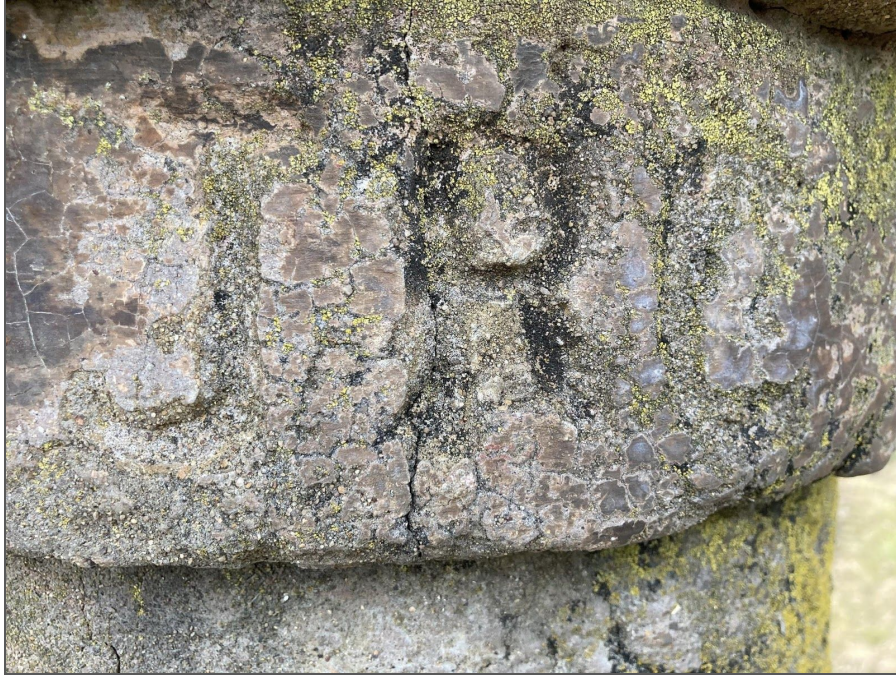
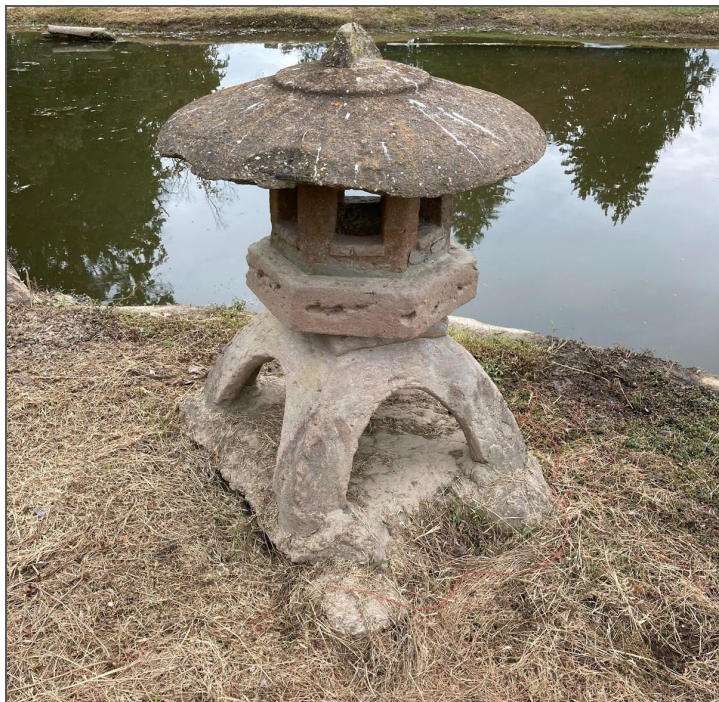
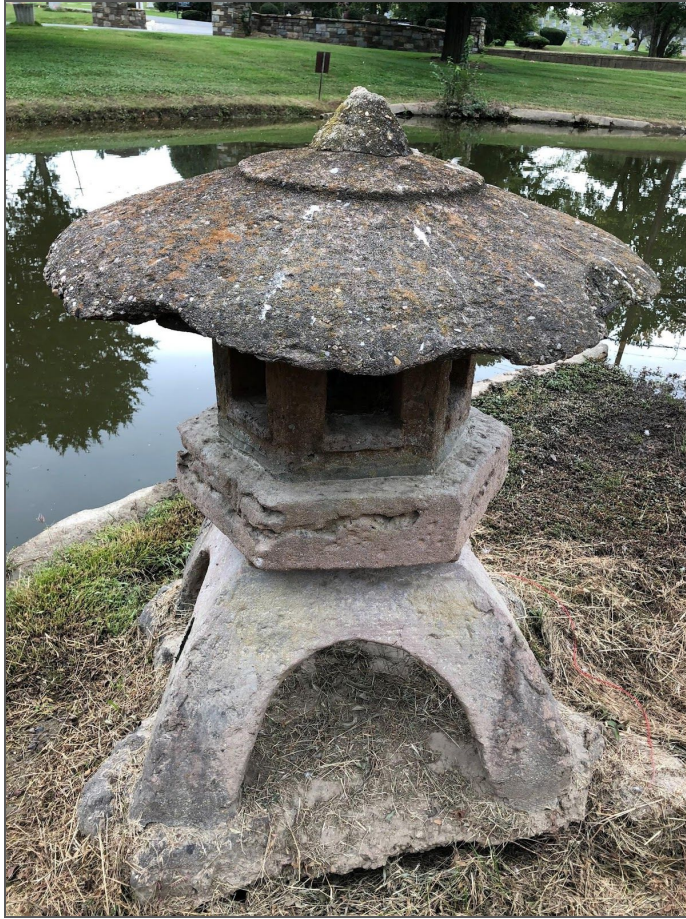
Chinese Lanterns

Condition: Both lanterns are in fair condition. Lantern 1 appears to have surface biological growth, and areas where the outer concrete coating has chipped away. On Lantern 2, the biological growth is concentrated at the top of the lantern. Some concrete has broken off around the top edges, exposing the rebar used to frame the sculpture.

Photo 15: Lantern 1 near Bridge of Life, Cedar Hill Cemetery

Photo 18: Lantern 2, areas where concrete has chipped off
Photo Source: Photograph taken by PALS Research Team

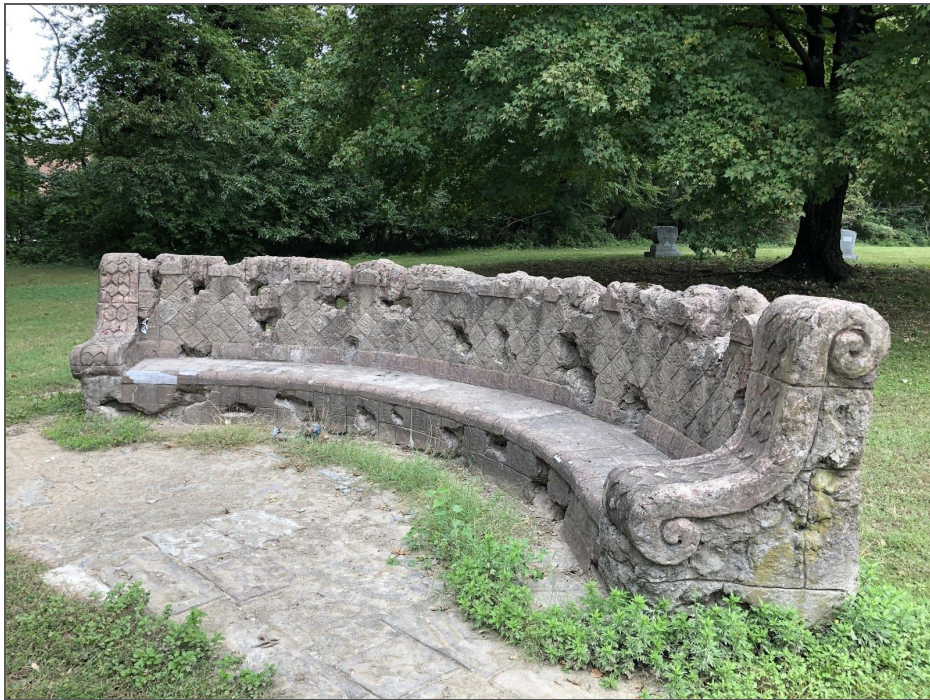
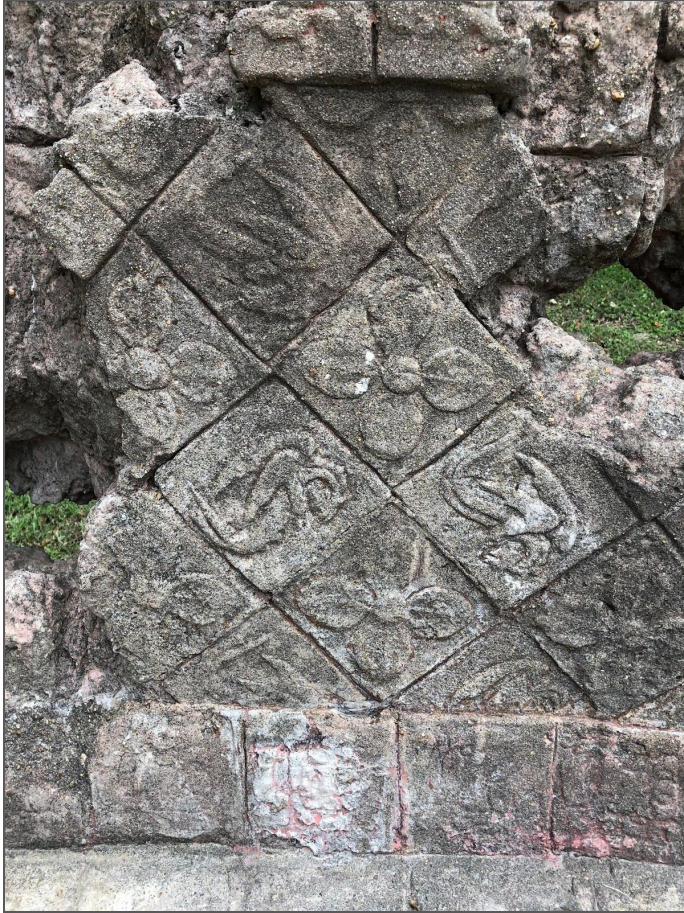
Mayan Influenced Bench

Condition: The bench is in good condition, although biological growth and pink staining is present in many areas. It is difficult to ascertain the extent of concrete spalling; the design's intentional holes may obscure actual issues.

Photo 19: [Mayan Influenced Bench, Cedar Hill Cemetery](#)
Photo Source: Photograph taken by PALS Research Team

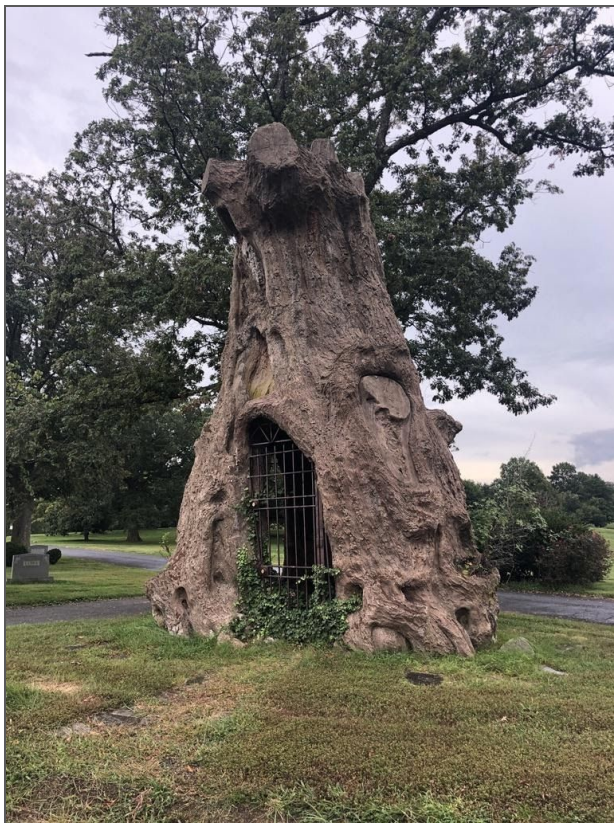
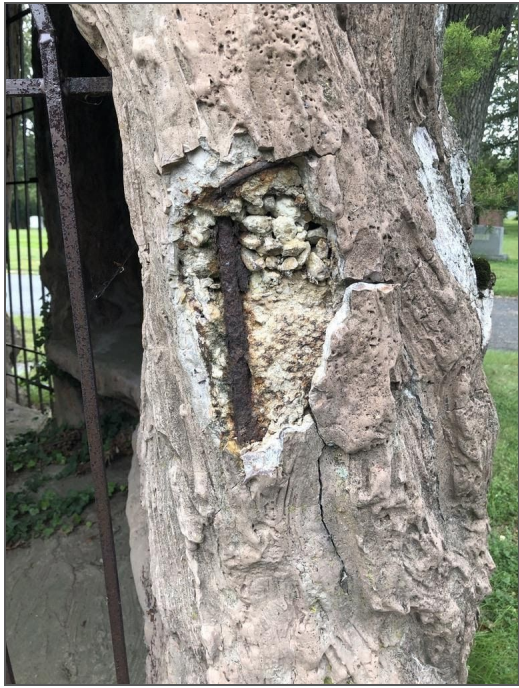
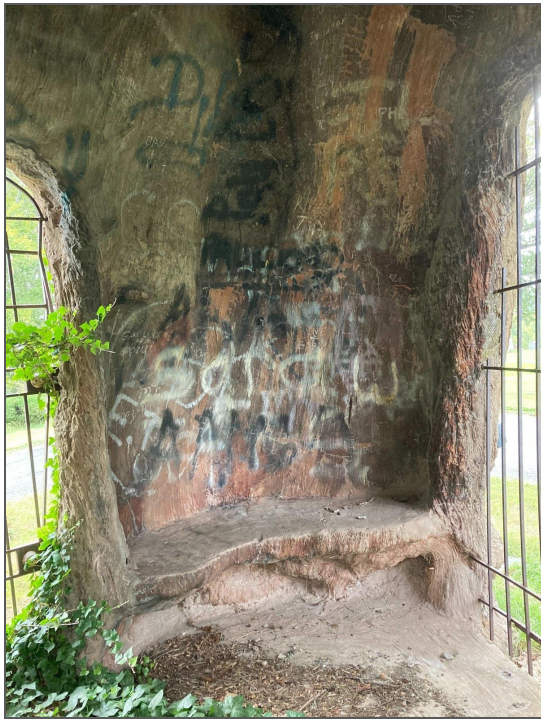
Hollow Tree Sculpture

Condition: This sculpture appears to be structurally sound and in fair condition, despite a variety of superficial issues. Large pieces of the outer concrete layer are missing, revealing the rebar and metal lath underneath. In addition to vegetation growing on the structure, the interior of the tree is completely covered with spray paint.

Photo 22: Hollow Tree Sculpture, damaged area where the outer concrete layer has fallen away, revealing the concrete and rebar underneath. The exposed rebar has begun to rust.
Photo Source: Photograph taken by PALS Research Team

Photo 23: Inside the Hollow Tree sculpture painted with graffiti

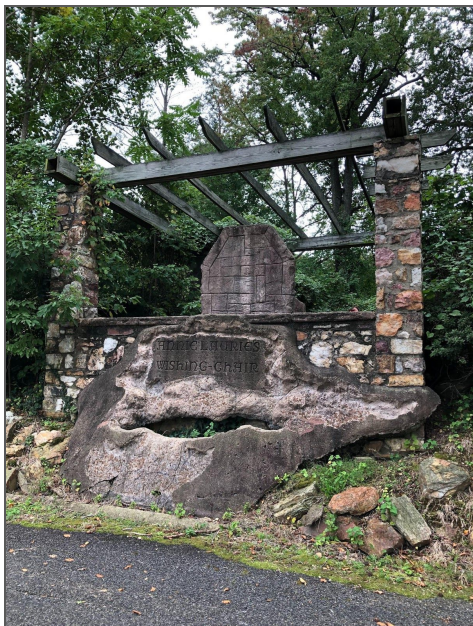
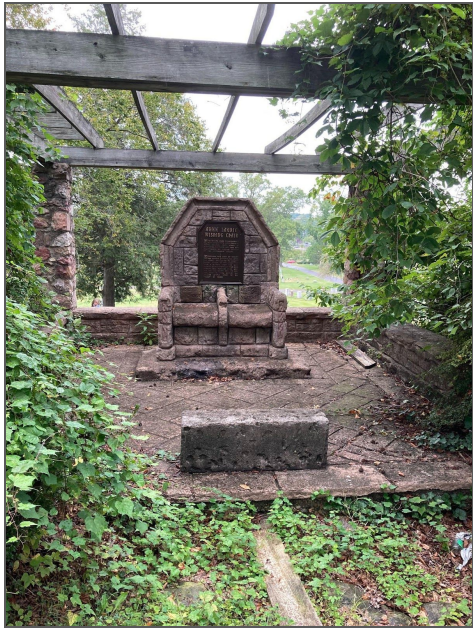
Condition: The sculpture's condition is good and, unlike some of the others, has no rebar showing. However, the concrete is beginning to crack and spall in some places and there are non-original markings inscribed into the back of the chair, likely from cemetery visitors. Additionally, the chair has small patches of vegetation growing on the concrete.

Photo 24: Rear view of Annie Laurie Wishing Chair
Photo Source: Photograph taken by PALS Research Team

Photo 25: Front view of Annie Laurie Wishing Chair
Photo Source: Photograph taken by PALS Research Team

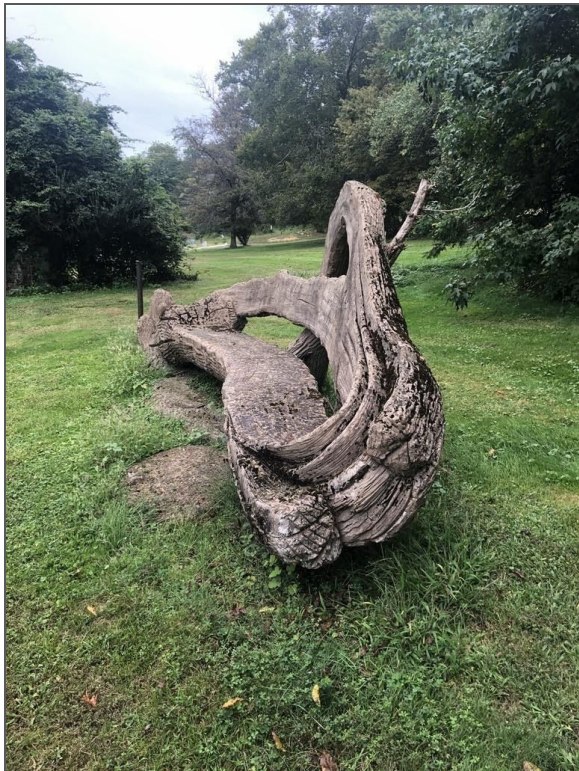
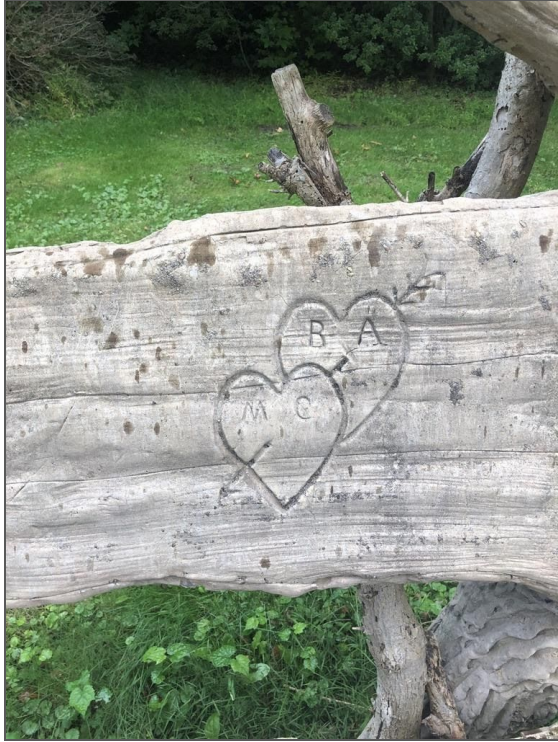
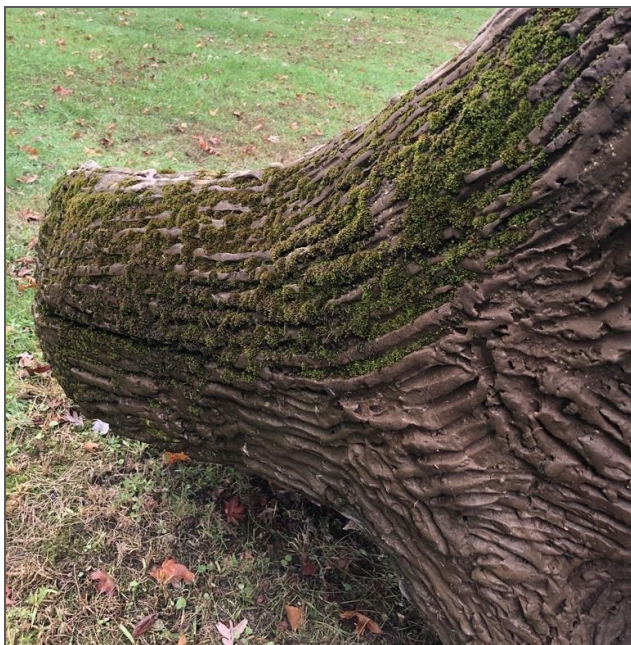
Fallen Tree Bench

Condition: The bench is in fair condition. its exterior coating has chipped in several areas, revealing rebar and metal lath, along with the rougher, base concrete layer. Vegetation is growing on various parts of the surface, mostly moss along the rear side of the backrest. The sculpture also shows some signs of vandalism, etched into the concrete, including two hearts pierced by an arrow with initials inscribed in the hearts, in the center of the bench.

Photo 29: Biological growth on the rear of the sculpture
Photo Source: Photograph taken by PALS Research Team

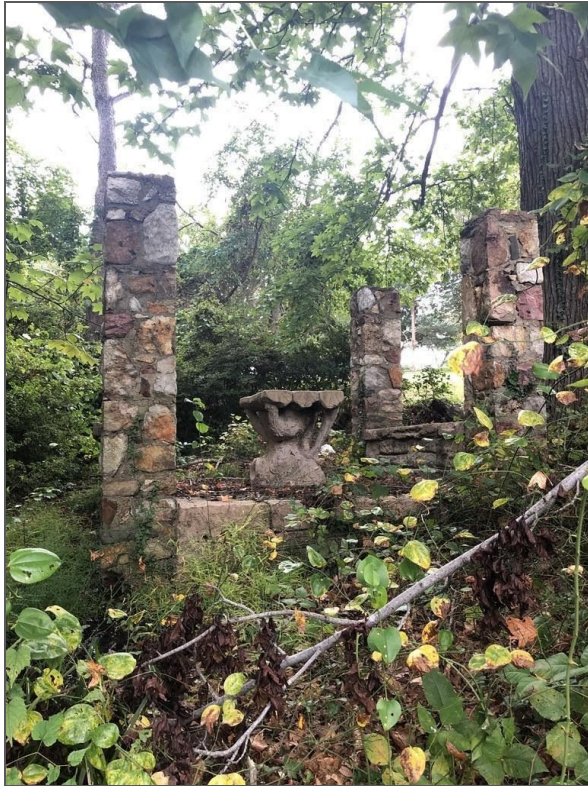
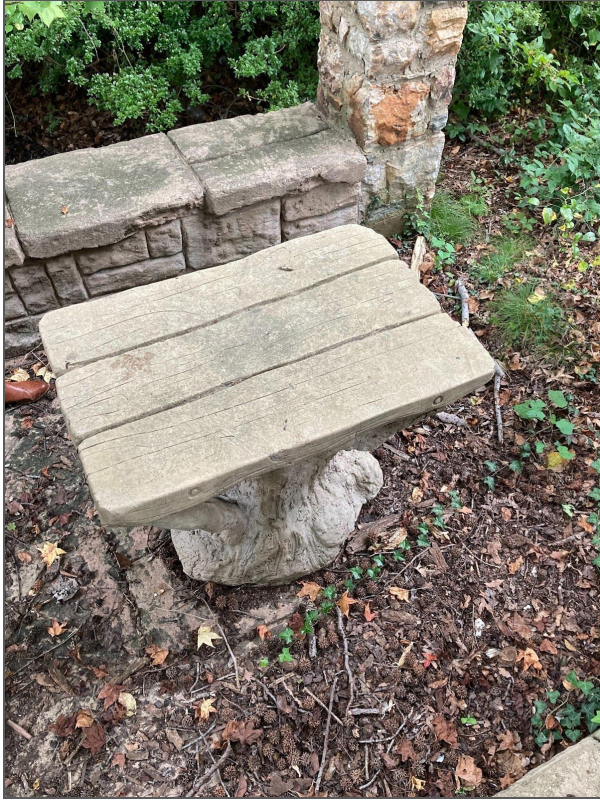
Wooden Table

Condition: Some vegetation is growing on the table's base and the pergola no longer in existence; nonetheless, this sculpture is in very good condition.

Photo 30: Faux wooden table set within fieldstone columns that once supported a wooden pergola

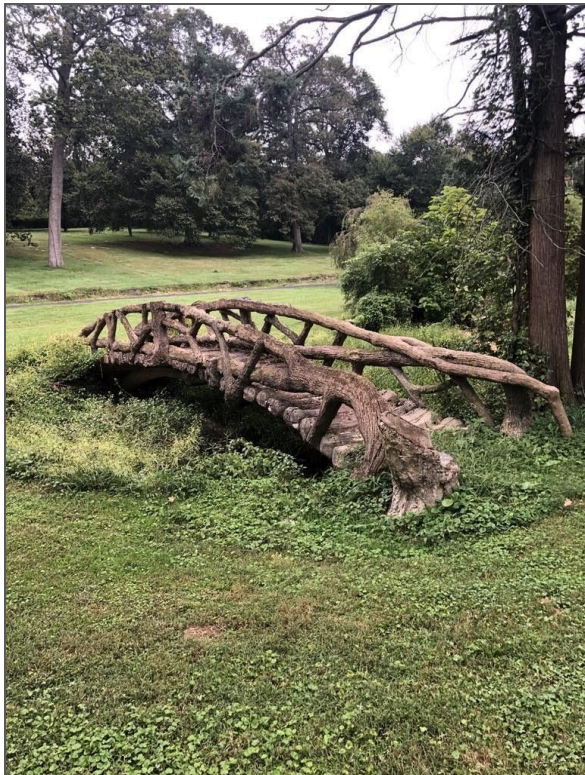
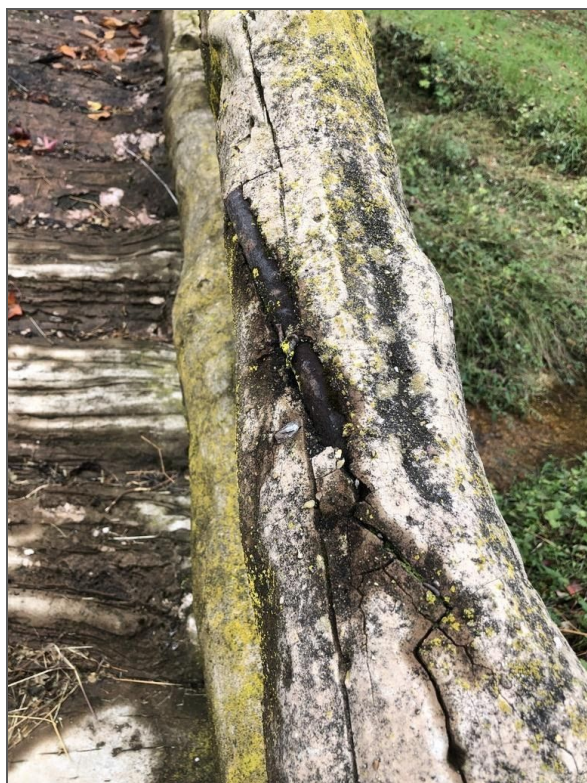
Condition: The bridge is in fair condition. As with the other sculptures, there is vegetation growing on it and there are many places where the finished coat of concrete has broken off, exposing the metal lath, rebar, and mixed concrete used to create the shape of the structure.

Photo 32: Fallen Tree Bridge, Cedar Hill Cemetery

Photo 33: These various problems are common to many of the sculptures, including cracking and breaking off of the outer layer of highly cementitious concrete, the exposure of rebar, and biological growth
